TECHNICAL BULLETIN

ISSUES WITH ASBESTOS CONTAINING SUBSTRATES

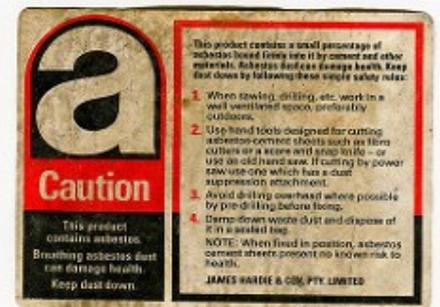
When in doubt about the sheet's age or composition, do not sand, and look for the asbestos warning sticker which may still be on the back of sheets manufactured after the mid 70's. The next picture is an example.
